DEPARTMENT OF NATURAL RESOURCES
DIVISION OF OIL, GAS AND MINING

RE: Site Inspection, Butt Mining Company, Sage Mine, S/037/058, San Juan County, Utah

Date of Inspection: August 14, 2002
Time of Inspection: 7:15-7:45 p.m.
Conditions: Clear, 80's
Participants: Doug Jensen and Paul Baker, DOGM

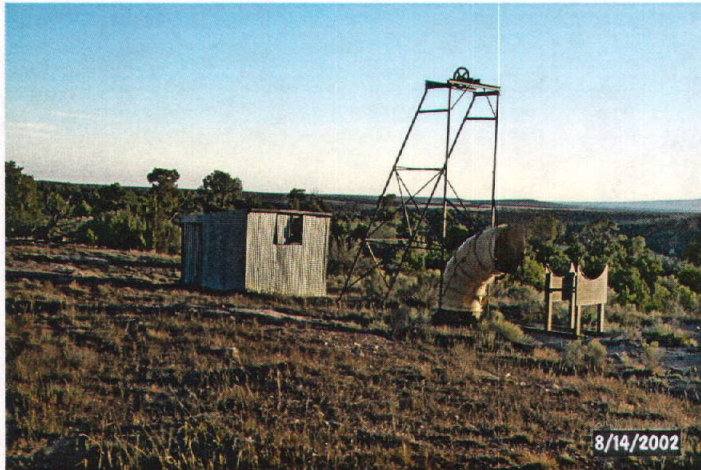
The site has been graded and revegetated, but it still has a shaft, a headframe, and a hoist house building (Photos 1-3). The vegetation cover is similar to adjacent areas and contains mostly native species.

Photo 1. Vent shaft, headframe, and hoist house. View is approximately to the southwest.

The vegetation is established well enough that this portion of the site could probably be released if all the facilities were gone. The site is stable with no danger to the environment or public safety that we could see.

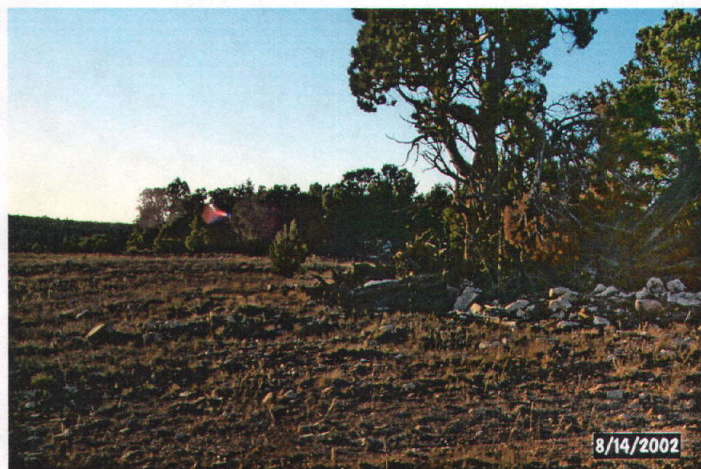
Photo 3. View is looking approximately northwest.
